U.S. Geological Survey Bulletin 2180

By W.Z. Savage, R.L. Baum, M.M. Morrissey, and B.P. Arndt

Introduction

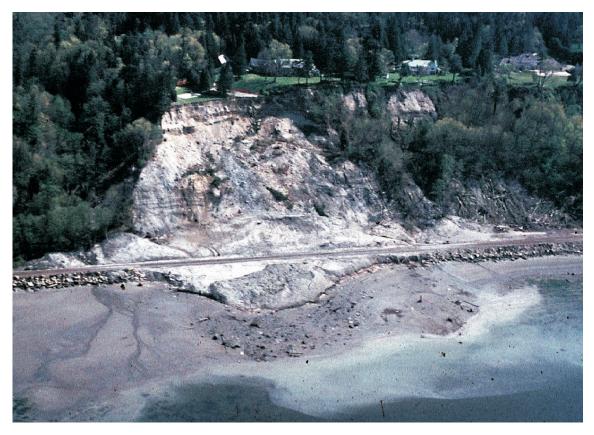
Figure 1 shows an oblique aerial view of a large deep-seated landslide that occurred at approximately 10:30 p.m. on January 15, 1997, at Woodway, Washington, 25 km north of downtown Seattle. This slide, which lasted for 15 to 20 seconds, buried railroad tracks at the foot of the bluff under 6 m of debris, derailed a passing southbound freight train, and pushed several rail cars into Puget Sound. Because deep-seated landslides are an important problem in Seattle, the U.S. Geological Survey (USGS) has instrumented the Woodway site to measure rainfall, ground-water pressures, and movement (Baum, Harp, and others, 1998) as part of a larger scale Seattle-area hazards study (Gori and others, 1999). Figure 2 shows an annotated aerial photograph of the borehole locations and instrumentation at the Woodway landslide site.

Figure 1. Oblique aerial view of a deep-seated landslide at Woodway, Washington. Photograph taken May 1997 by E. Harp, USGS.

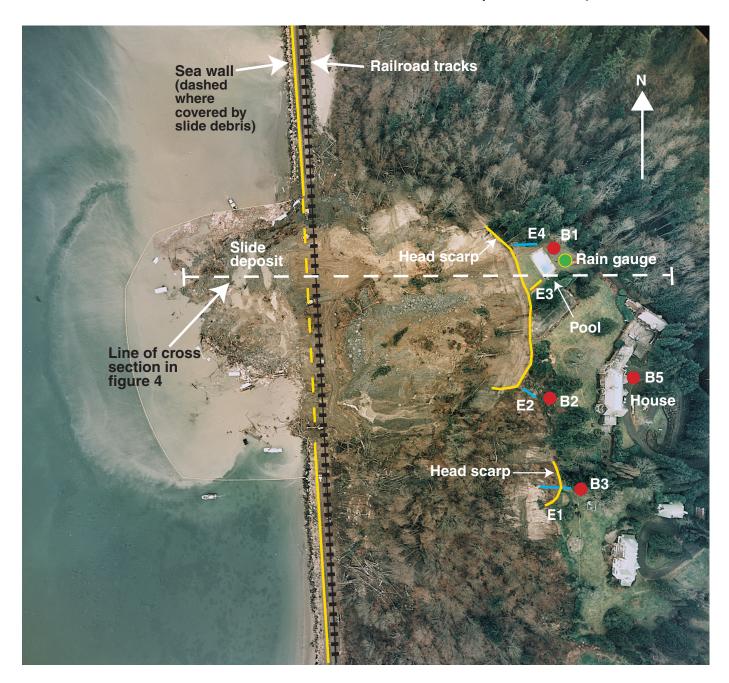
Figure 2. Annotated aerial photograph of the Woodway landslide site (not to scale). Instrumented boreholes are labeled B1, B2, B3, and B5. Extensometers are labeled E1, E2, E3, and E4.

As figure 3 is not to scale, a scaled cross section of the Woodway landslide, shown in figure 4, was constructed. The location of this cross section is shown in figure 2. The geology is from Arndt (1999). Note that Recessional outwash replaces Vashon till at the top of this section. The approximate ground

From the data shown in figure 5 it can be inferred that, at the location of borehole B2 (see figs. 2 and 3), a ground-water table of approximately 2.4 m average thickness has been perched near the top of the relatively impervious Lawton Clay since September 1997. Also, pore-pressure transducer data collected since September 1997 at a depth of 28 m in borehole B3 show that at that location (see fig. 2) a ground-water table of approximately 1.2 m average thickness is perched near the top of the relatively impervious Lawton Clay. Because of noisy signals or and other equipment problems, no data are given here for pore-pressure transducers in boreholes B1 and B5.
